**Attachment R -
Reston Area HQ
Maintenance Yard**

**VDOT MS4 (General Permit No. VAR04)
Reston Area Headquarters
VDOT District No. 9**

Date of Visit: October 24, 2012
Entry Time: 8:45 a.m. (approx)
Exit Time: 12:00 p.m. (approx)

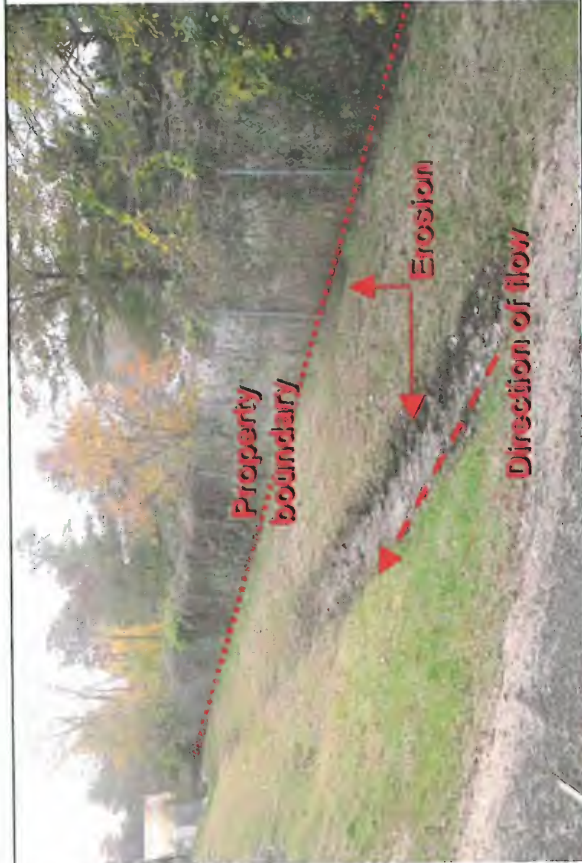
8. Visible erosion (rill formations) was observed along the southern fence line in the southeastern portion of the Facility, south of salt spreader storage bays 15-23 (see Photographs 1 through 6). Stormwater runoff from the Facility discharges off-site at multiple discharge locations under the southern perimeter fence into the Dulles Toll Road Right-of-Way, north of Westbound Dulles Toll Road.

Photograph 1 – View facing southeast of a stormwater conveyance ditch along the southern perimeter of the Facility. Note erosion was observed.

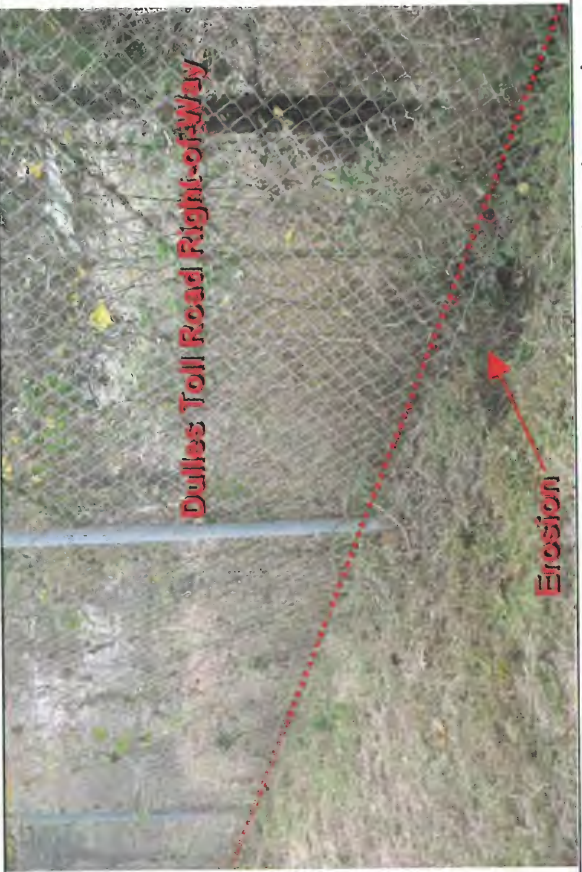
Photograph 2 – Close-up view of erosion, shown in Photo 1, occurring under the southern fence, in the southeastern corner of the Facility.

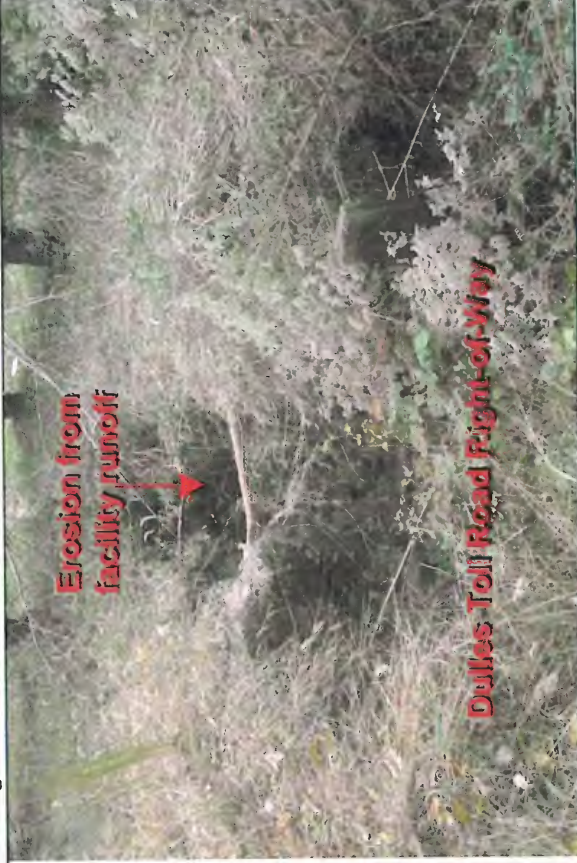
Photograph 3 – Erosion observed off-site in the Dulles Toll Road ROW to the south of the Facility, apparently caused by facility stormwater runoff.		
 	Photograph 4 – View facing west of the stormwater conveyance ditch, shown in Photo 1, along the southern perimeter of the Facility.

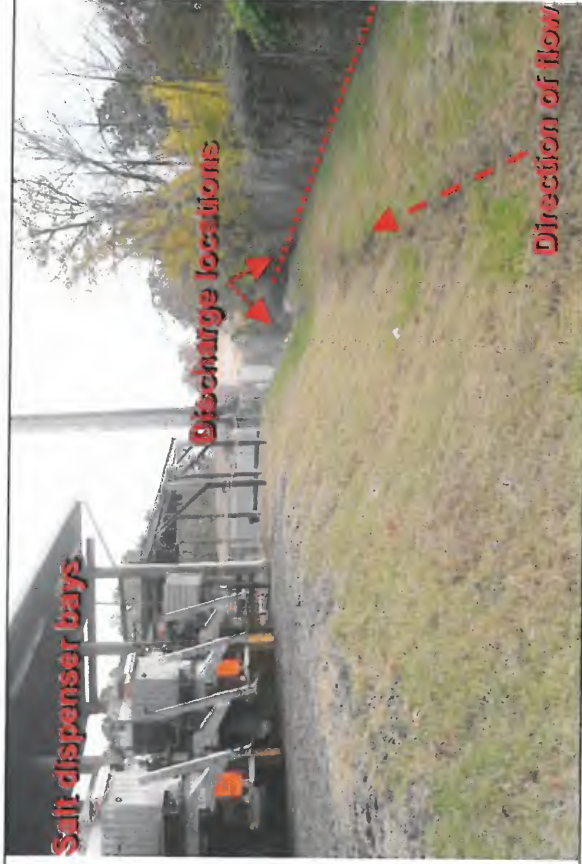
Photograph 5 – View facing east of the stormwater conveyance ditch, shown in Photos 1 and 4, along the southern perimeter of the Facility.

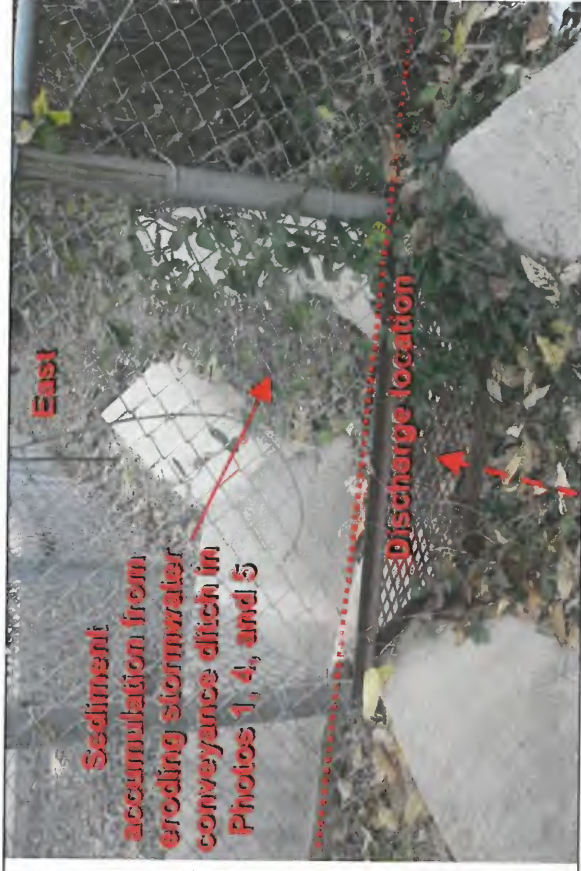
Photograph 6 – Close-up view of a stormwater discharge location in the southeast corner of the Facility. Note the sediment accumulation.

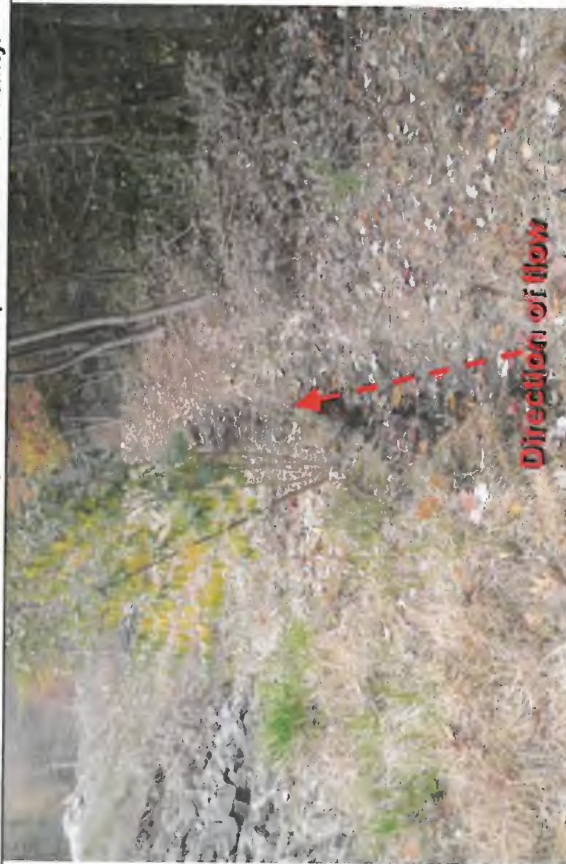
9. Erosion (rill formations) was observed in an internal drainage swale on the western side of the Facility, north of the asphalt and trash storage area (see Photographs 7 and 8). Evidence of sediment transport from the drainage swale to the west was observed.

Photograph 7 – View facing east of a stormwater conveyance ditch in the central-west portion of the Facility, adjacent to the asphalt mill stockpile.

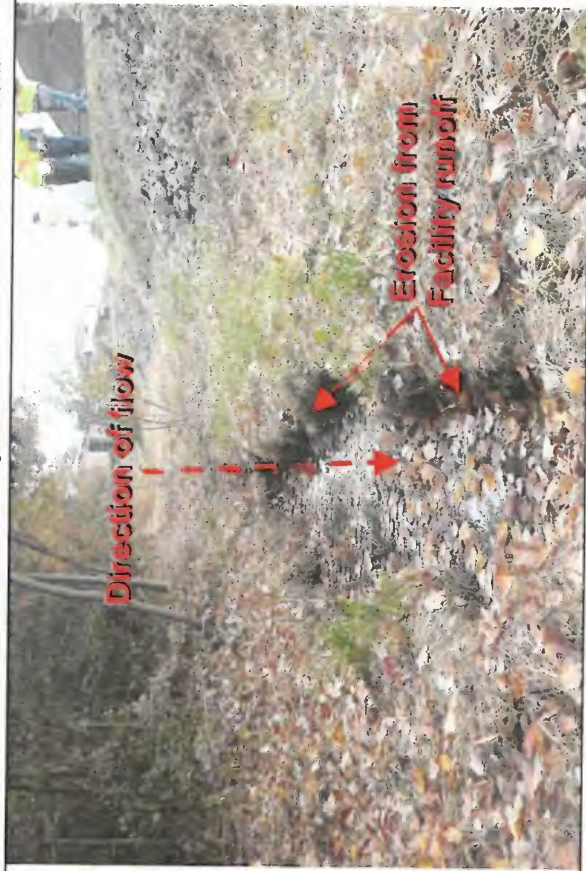
Photograph 8 – View facing west of erosion occurring in the stormwater ditch in the central-west portion of the Facility, shown in Photo 7.

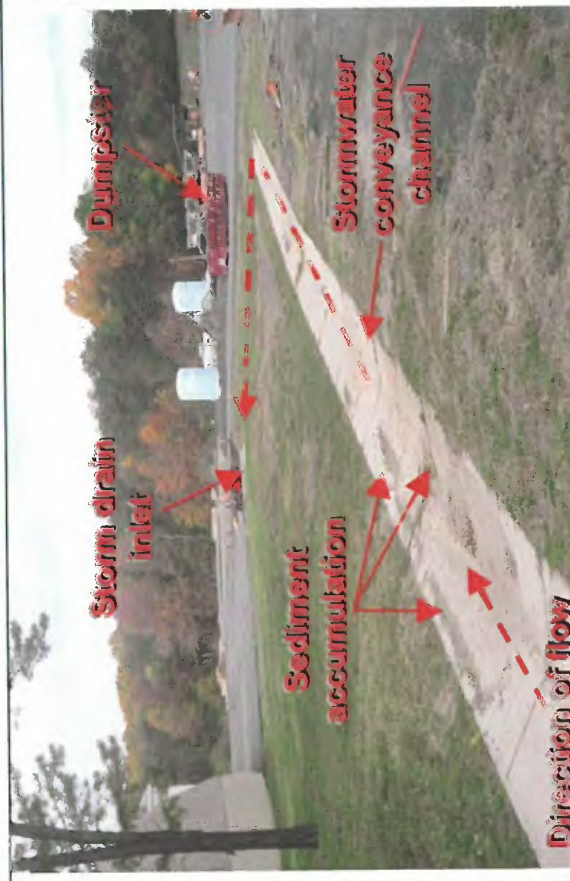
10. Sediment and vegetative debris was observed inside a stormwater conveyance channel in the south-central portion of the site (see Photographs 9 and 10). A storm drain inlet located downgradient of the conveyance channel was observed without inlet protection (see Photographs 11 and 12). The EPA Inspection Team observed sediment accumulation inside the stabilized storm drain outlet channel located at the storm drain outlet pipe on the western side of the Facility, adjacent to the asphalt and trash storage area (see Photographs 13 and 14). The outlet pipe is located just upgradient of the western discharge location.

Photograph 9 – View facing northwest of sediment in a stormwater conveyance channel located in the south-central portion of the Facility.

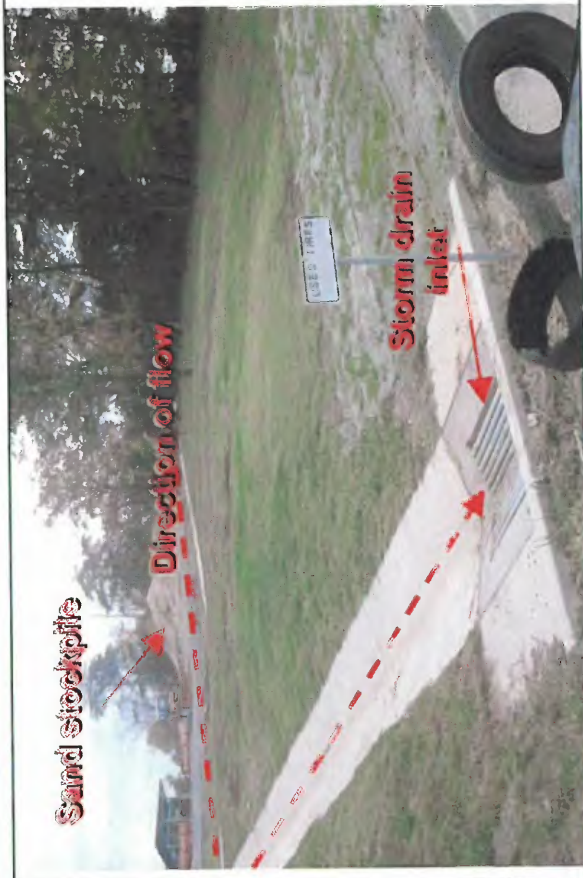
Photograph 10 – View facing southeast of the discharge location for the stormwater conveyance channel shown in Photo 9.

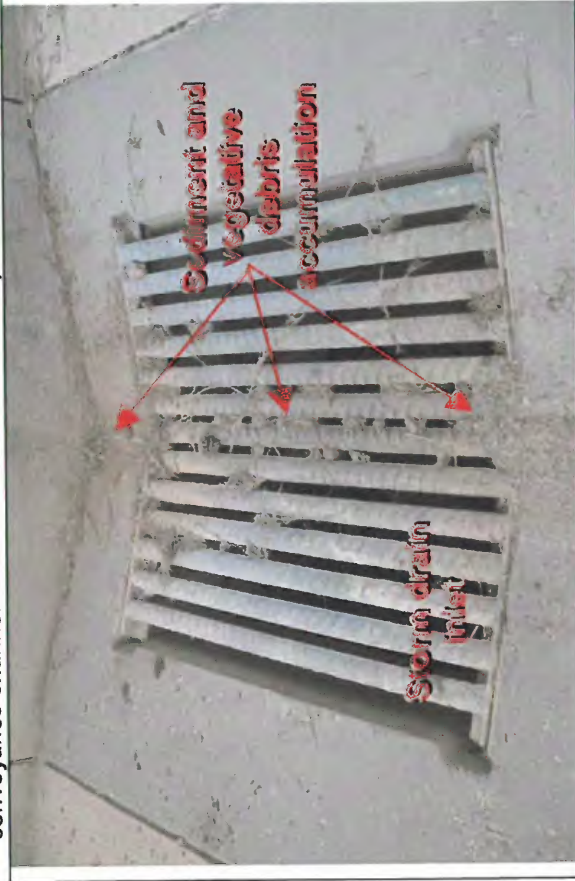
Photograph 11 – Close-up view of sediment and vegetative debris accumulation on the storm drain grate, shown in Photo 10.

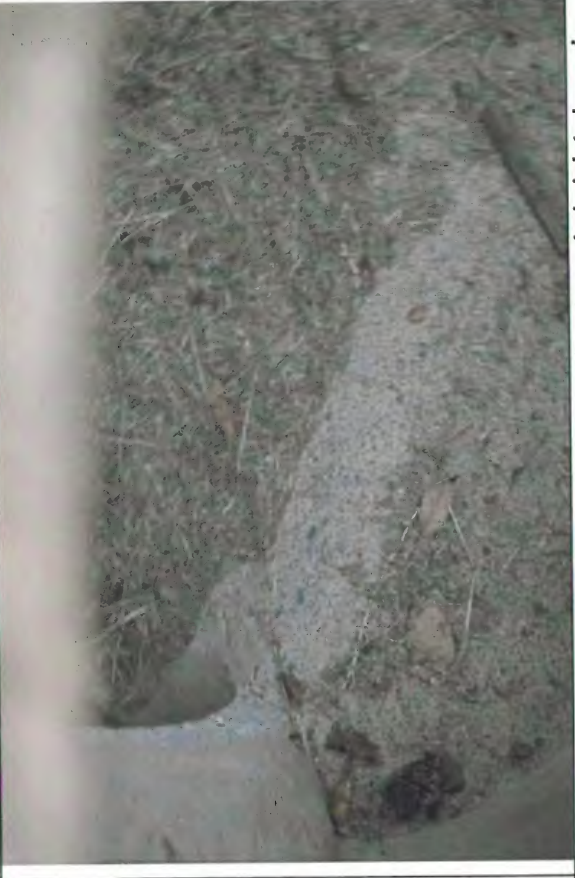
Photograph 12 – Close-up view of inside the storm drain inlet shown in Photos 9, 10, and 11.

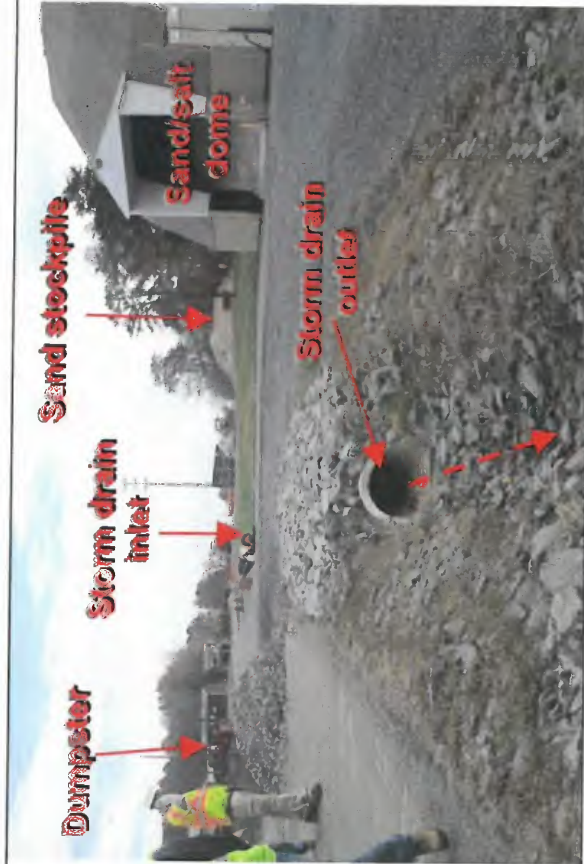
Photograph 13 – View facing east of the discharge location for the storm drain inlet shown in Photos 9, 10, and 11.

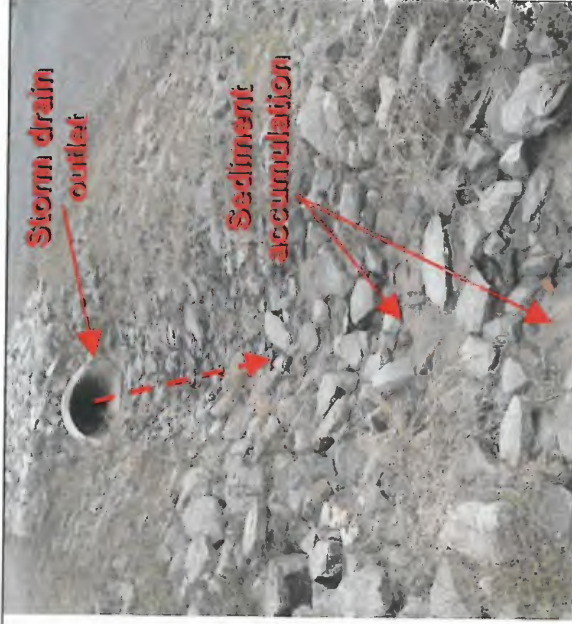
Photograph 14 – View facing east of sediment accumulation at the discharge location shown in Photo 13.

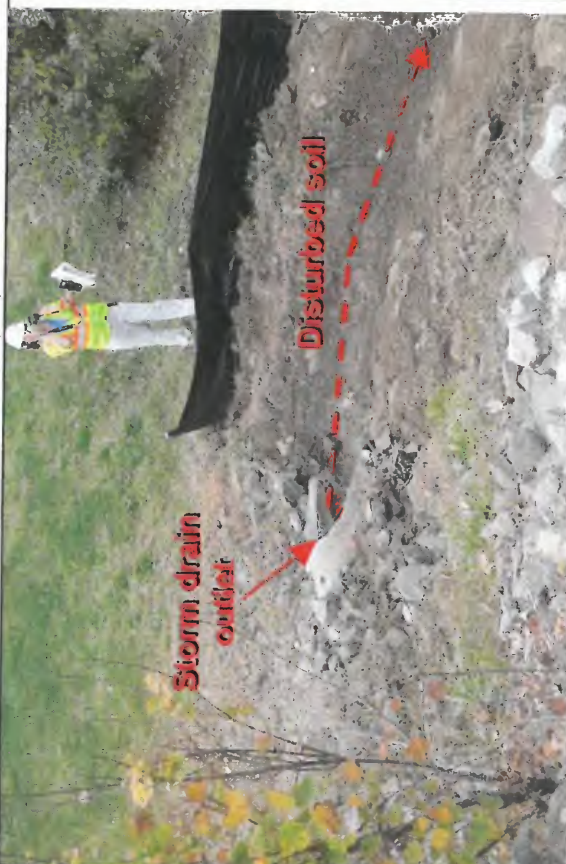
11. Disturbed soil was observed downgradient of a storm drain outlet pipe that discharged off site to the west, adjacent to the asphalt and trash storage area (see Photographs 15, 16, and 17). Silt fence had been implemented between the disturbed soil and the adjacent wetland to the west and evidence of previous sediment-laden surface runoff was observed leading offsite (see Photographs 16 and 18). The silt fence appeared to be newly installed to the EPA Inspection Team.

Photograph 15 – View facing southwest of a stormwater discharge location in the central-west portion of the Facility. Note the disturbed soil.

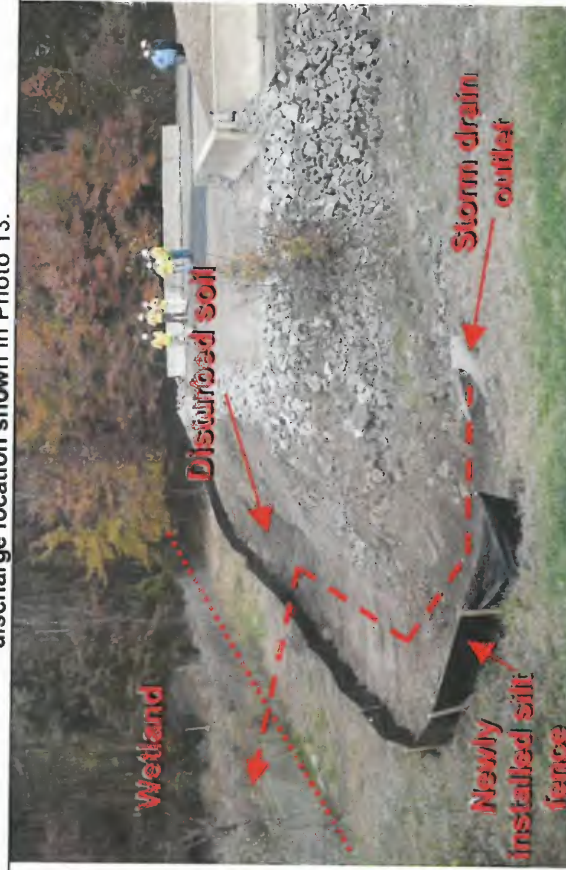
Photograph 16 – View facing north of the stormwater discharge location shown in Photo 15. Note the disturbed soils and adjacent wetland.

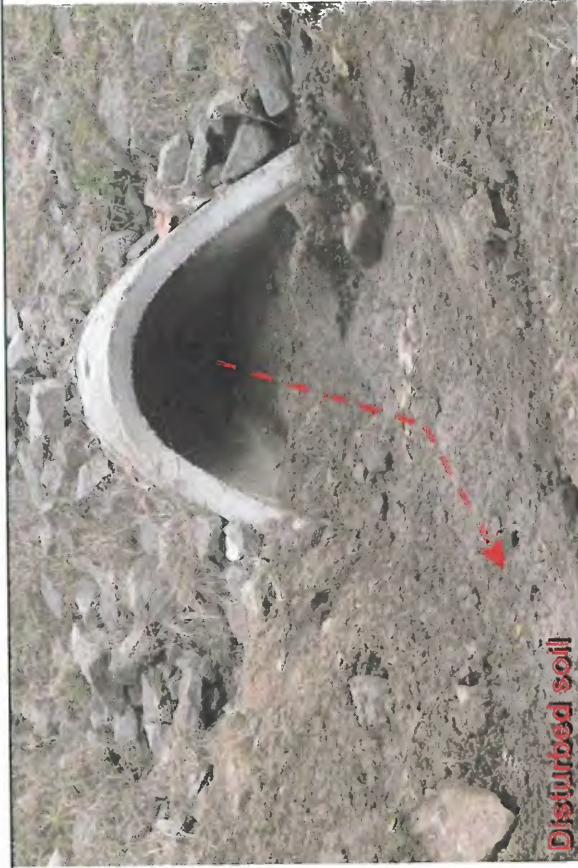
Photograph 17 – Close-up view of the stormwater discharge location shown in Photos 15 and 16.

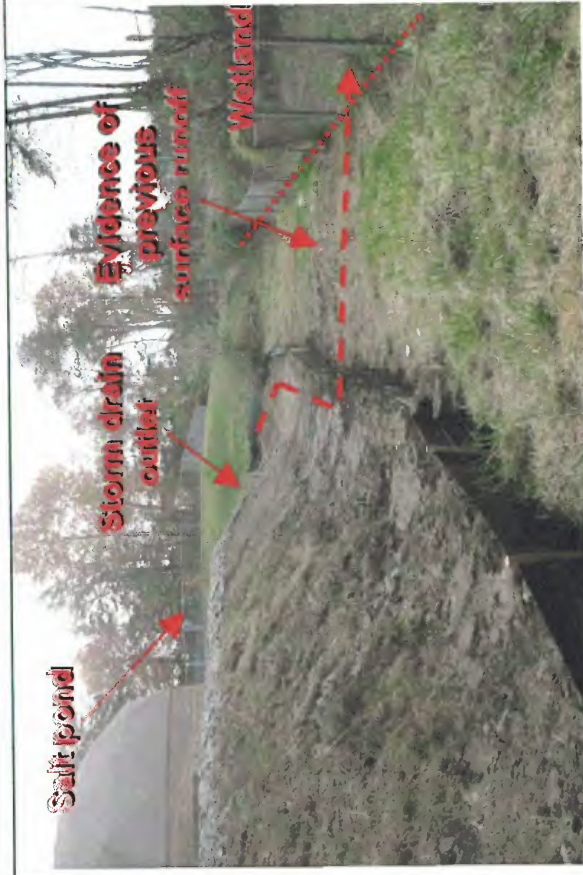
Photograph 18 – View (facing south) of evidence of surface runoff from the stormwater discharge location shown in Photos 15, 16, and 17.

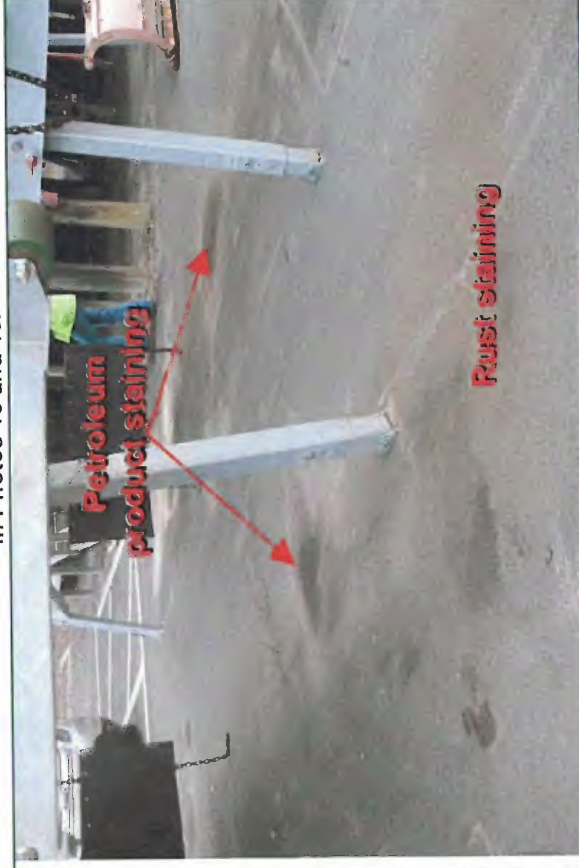
12. Visible hydraulic fluid, rust, and salt staining was observed underneath a piece of salt dispensing equipment on the northeast portion of the Facility (see Photographs 19 and 20).

Photograph 19 – View facing north of petroleum product and rust staining on the impervious surface, underneath salt dispensers in the northeast portion of the Facility.

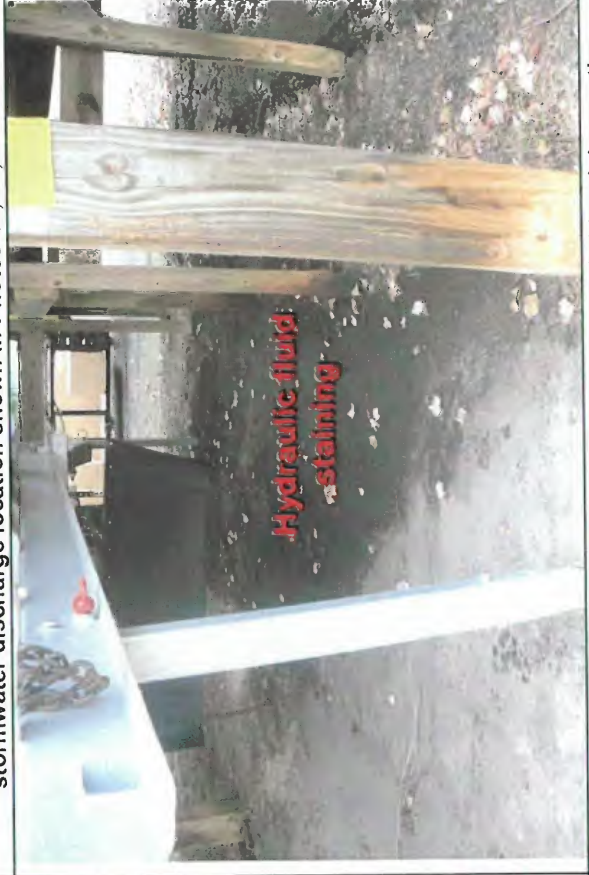
Photograph 20 – View facing north of hydraulic fluid staining on the impervious surface, underneath salt dispensers in the northeast portion of the Facility.

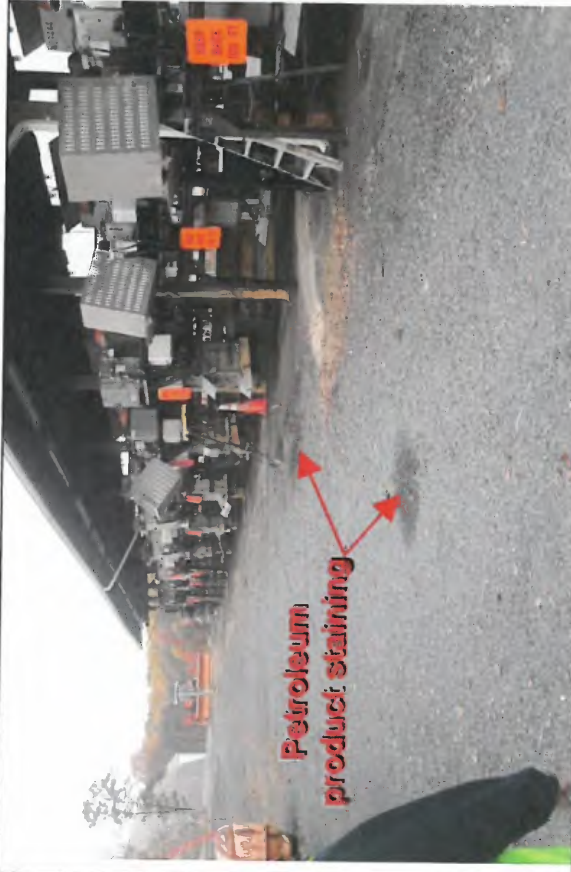
13. Visible staining from a petroleum product was observed on the gravel surface, south of the salt dispenser bays along the southern perimeter of the Facility (see Photograph 21).

Photograph 21 – View facing west of petroleum product staining on the ground surface, south the salt dispenser bays in the southeast portion of the Facility.

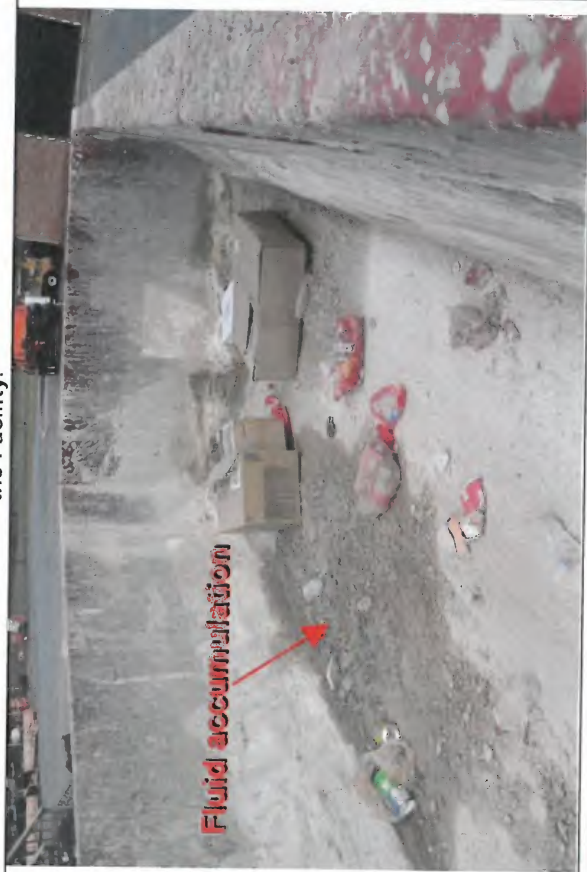
14. A solid waste disposal dumpster located in the central portion of the Facility was observed actively leaking fluid onto the impervious surface below. Visible staining from unknown fluids was observed on the impervious surface underneath and around the solid waste dumpster (see Photographs 22, 23, and 24).

Photograph 23 – Close-up view of evidence of fluid accumulation inside the uncovered dumpster shown in Photo 22.

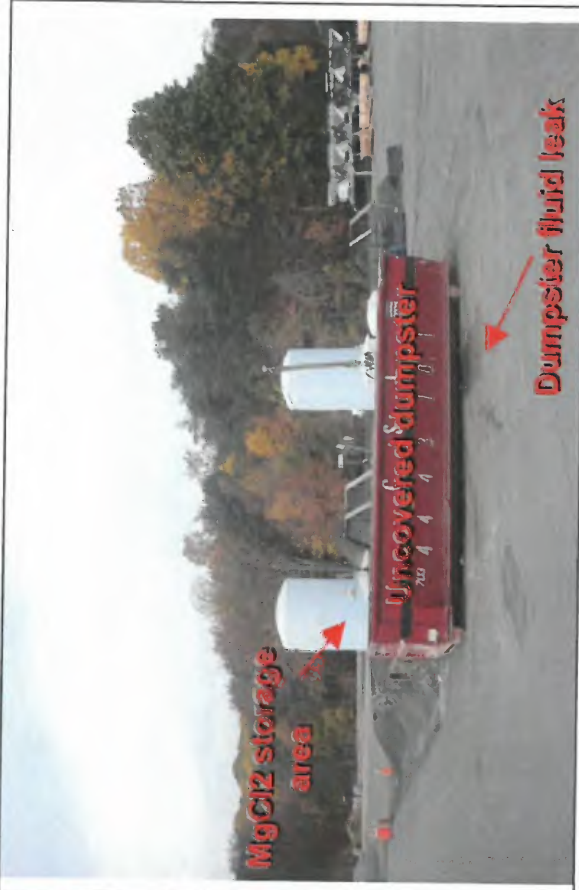
Photograph 22 – View facing west of an uncovered dumpster located in the central portion of the Facility, adjacent to the liquid magnesium storage area. Note the dumpster was leaking fluid onto the impervious surface.

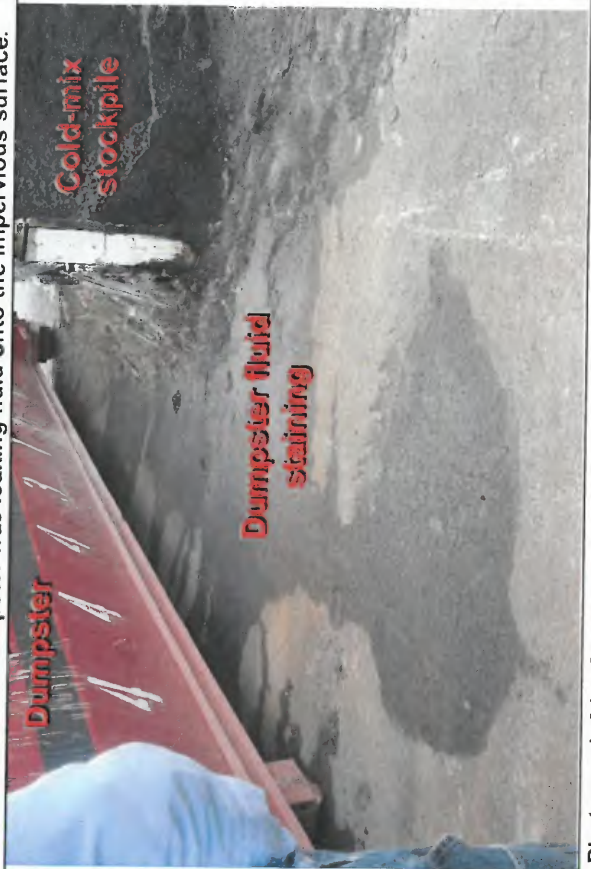
Photograph 24 – Close-up view of fluid staining on the impervious surface underneath the uncovered dumpster shown in Photos 22 and 23.

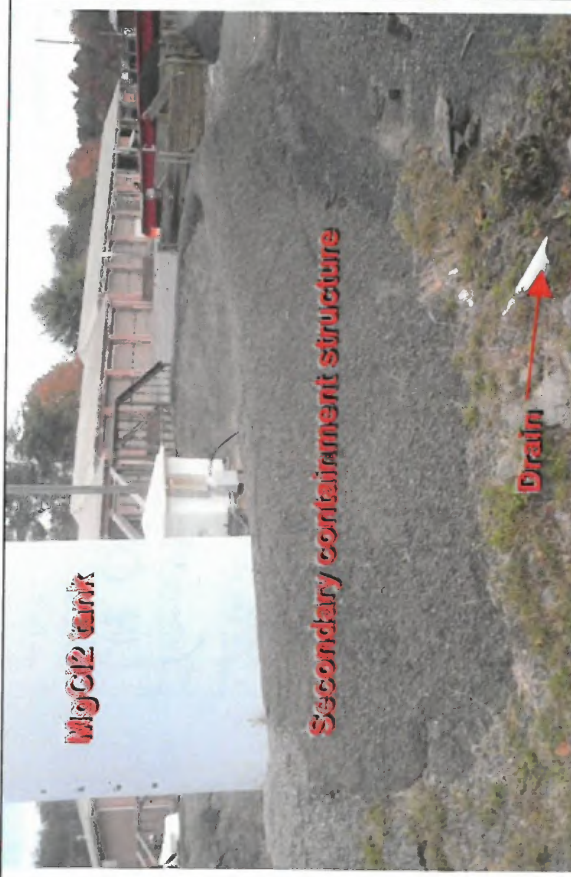
17. The liquid magnesium chloride storage tank was equipped with a secondary containment structure. However, an under drain passing through the secondary containment was not plugged to prevent product transport in the event of a spill or leak (see Photograph 28 and 29).

<p>Photograph 29 – View facing northeast of the unplugged under drain leading from the liquid magnesium secondary containment area.</p>

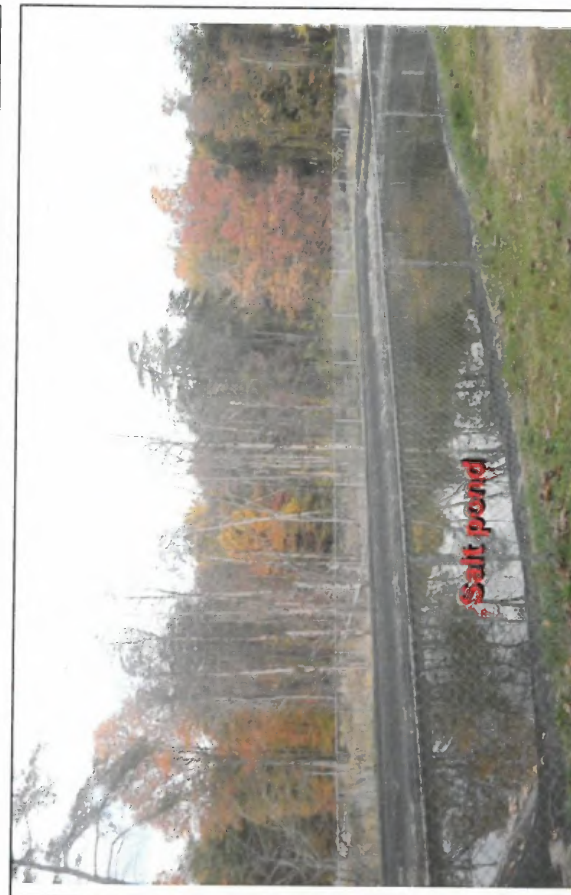
5. Facility staff explained that the salt pond is regularly drained to the sanitary sewer system; however, documented inspection records are not maintained to assess or document the freeboard in the pond.

<p>Photograph 30 – View facing northwest of the Facility salt pond located in the southwest corner of the Facility.</p>
